# Muramba and Mugonero, Rwanda January 2006: DESIGN REPORT

## “Sustainability Through Stewardship”

EWB-University of Colorado at Boulder  
[www.ewb-cu.org](http://www.ewb-cu.org)

Prepared: February 2006

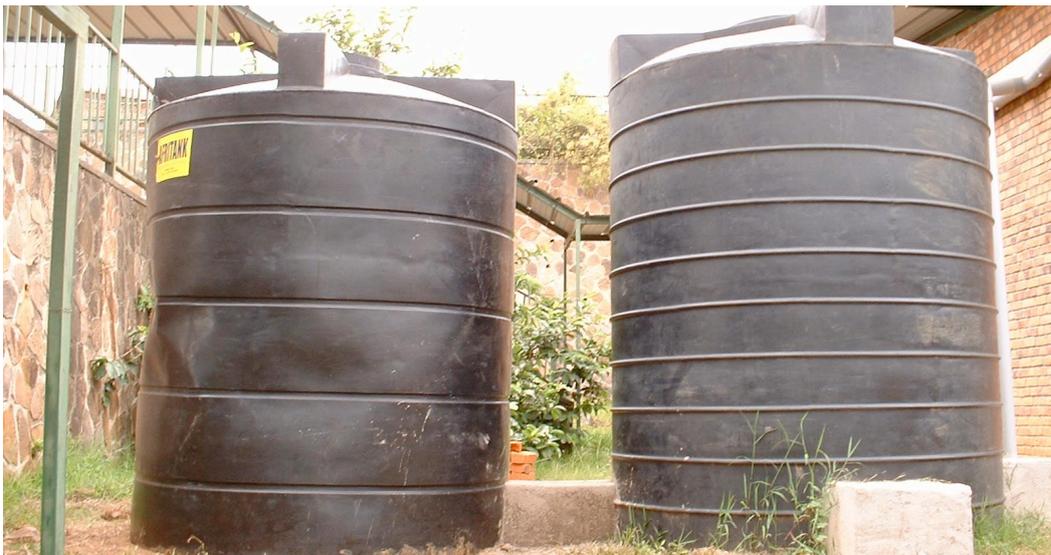
**Tank junction with masonry housing. The new tank is on the left and the old tank is on the right. The dents in the new tank were caused during transport and will disappear when the tank is filled for the first time. The masonry boxes in the lower right corner are the tap and drain housings.**

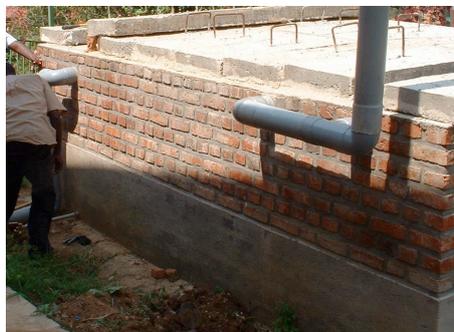
The cafeteria rainwater tank was only two thirds complete when we left Muramba in May, '05. It was two weeks later when we got word that the workers had finished the job. We left explicit instructions on how the tank was to be finished, however some of those instructions were not followed. There were also some minor design flaws that became apparent when we inspected the completed tank. What follows is an explanation of these problems and their solutions.

**A photograph of the improper placement of the tank inlets. The inlet closest to the down-pipe is the foul flush inlet, the other one is the main tank inlet.**

An alternative to the installation of an inverted “U” junction and a float valve is to relocate the foul flush inlet 4” inches downward as dictated by the original design. This would also accomplish the goal of preventing foul flush water from entering the main tank however; the water in ending up in the main tank would be of slightly lower quality due to the clean water mixing with the foul flush water as it travels by the foul flush inlet. This alternative would require some fairly difficult masonry to implement but it would allow us to avoid using a float valve resulting in a simpler system. A decision between these two alternatives will be made before our next visit.

To prevent something like this from happening again, it is important that those left in charge of finishing our work be better informed, through discussions, drawings, and calculations, of critical design items like the locations of tank inlets. It would also be helpful to have inspection visits performed by local team members like Jean Pierre or Pamela to insure that the work is completed as designed and that further questions are dealt with appropriately.

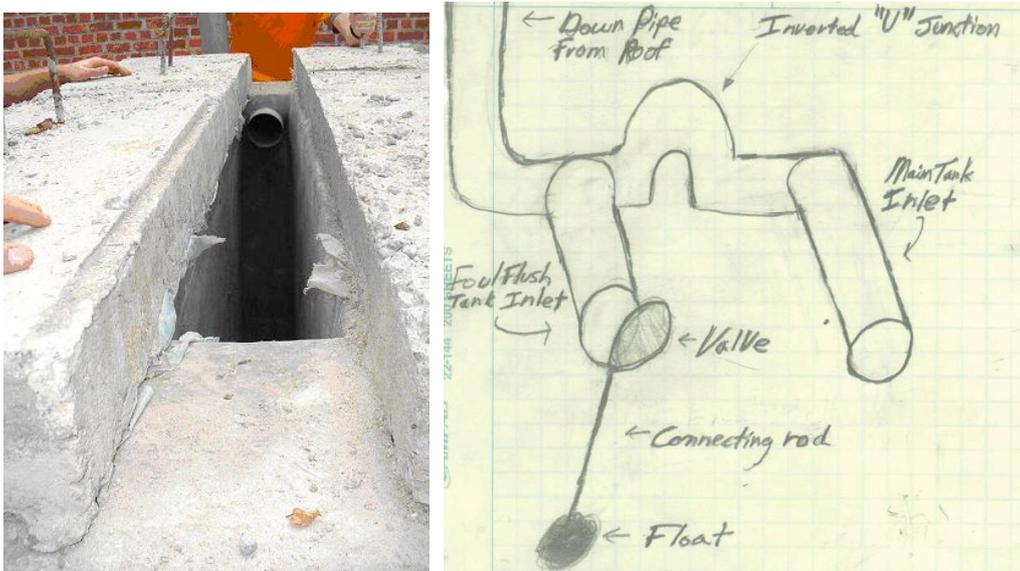
**Left: Cafeteria foul flush chamber. Right: Proposed modifications to the foul flush design**

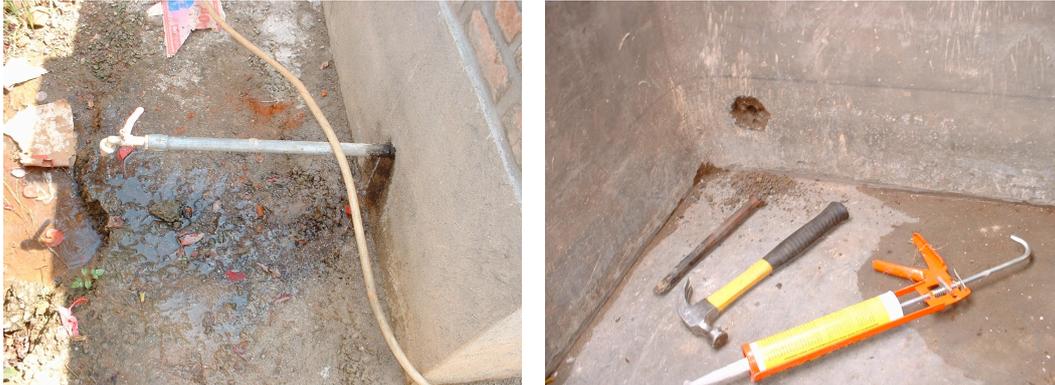
**Left: Water leaking from the pipe-tank junction. Right: A photograph of the repair in progress**

Future installations of pipes in masonry tank walls must insure that that proper mortar is used to fix the pipe in place. In addition, fixtures that will see daily use must be reinforced to withstand the stress of frequent operation. This reinforcement could be achieved with a masonry housing designed to secure the pipe against torsional loads induced by a user operating the tap. On our next visit, we intend to implement this solution.

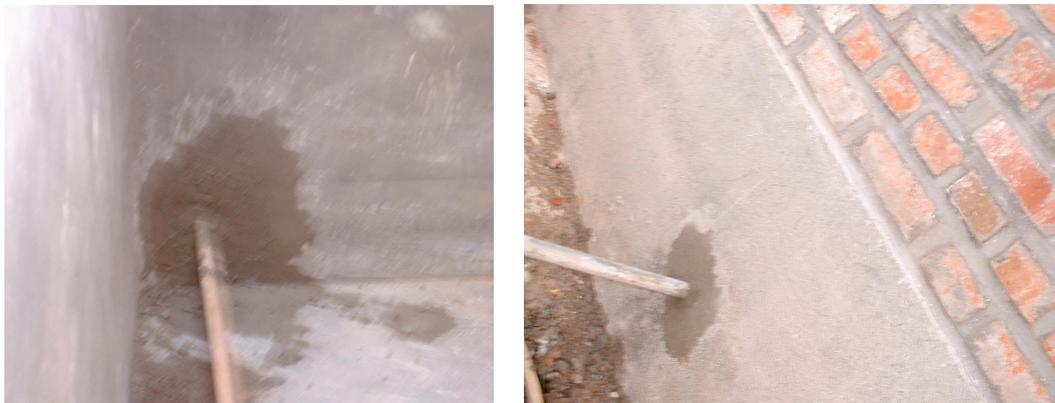
**Left: Internal view of the repaired pipe-tank junction. A broom handle was used to keep cement out of the pipe while the cement hardened. Right: External view of the repaired junction**

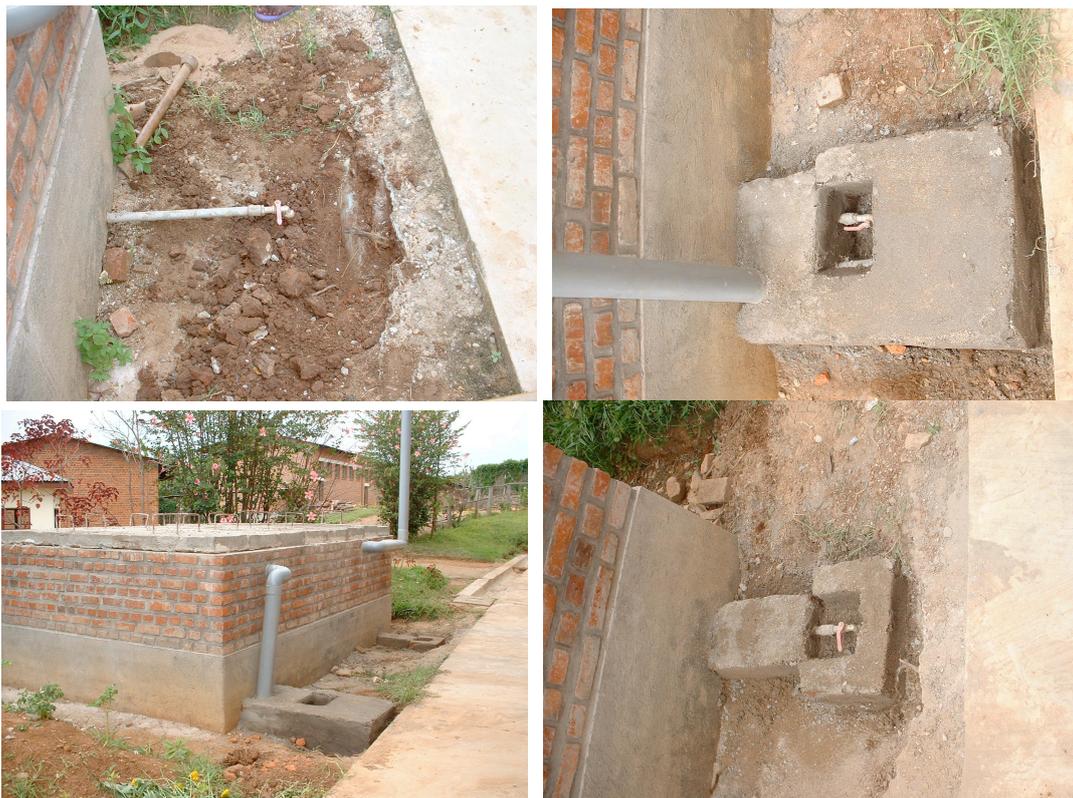
**Protective masonry housings for the tank drains and the overflow pipe. The image in the upper left shows the situation prior to our improvements. The pre-existing wastewater line is buried along the edge of the concrete walkway.**

overflow pipe from foot traffic. Sections of rubber hose were used to connect the drainage taps to a preexisting waste water pipe and the lines were then enclosed in protective masonry housings.

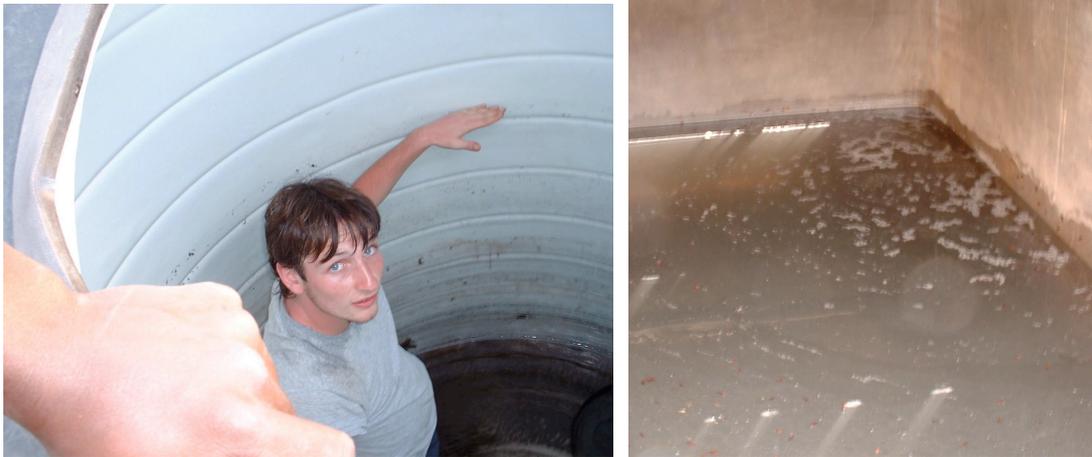
**Left: A member of the team indicates the apparent high-water line in the dormitory system. The excess of dirt in the tank is a result of the foul flush being non-operational for an unknown period of time.**  
**Right: Contaminated water in the cafeteria cistern as a result of faulty foul flush construction and operation.**

While we have encountered some difficulties with the implementation of these systems; the repairs, improvements, and training performed on this visit should significantly improve their performance. The dormitory system should now be functioning optimally with no water loss, a fully functional foul flush unit and expanded capacity. The cafeteria system should also not experience any water loss; however, it will continue to operate with compromised foul flush system until we are able to make the necessary modifications in May '06.

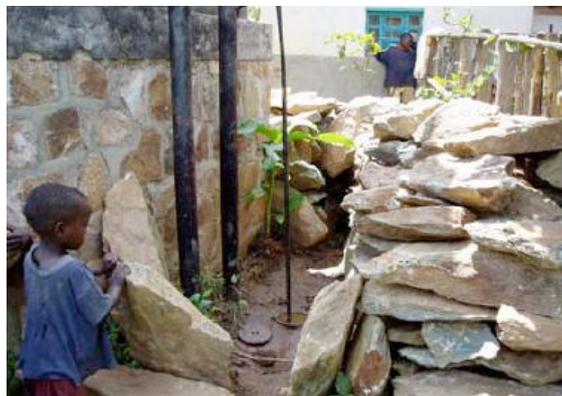
the backwash tank. This valve is operated with a 6 foot long metal key. Louie reports that the keyhole is often jammed with pebbles and that this is a significant nuisance. The figure below shows the key in the valve keyhole.

**Flow diversion valve area. The valve keyhole is the hole on the ground with the metal rod sticking out. The metal rod is the valve key.**

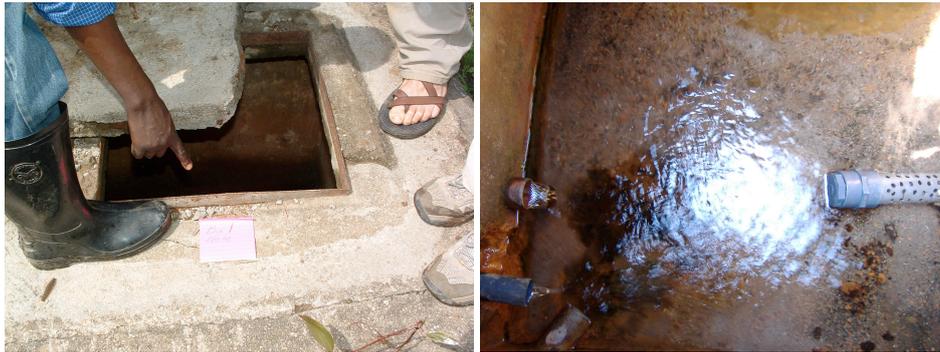
**Left: External view of collection box #1. Right: Internal view of collection box #1. The pipe in the lower left corner is submerged**
