# Muramba and Mugonero, Rwanda January 2006: DESIGN REPORT

## “Sustainability Through Stewardship”

EWB-University of Colorado at Boulder  
[www.ewb-cu.org](http://www.ewb-cu.org)

Prepared: February 2006

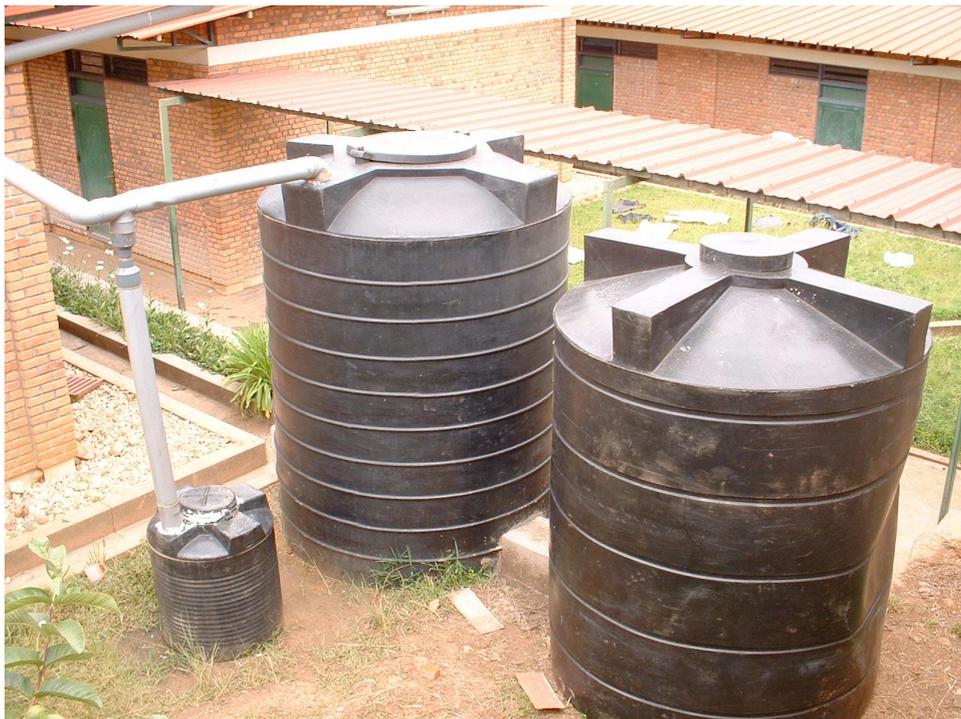
**Elevated view of the expanded system. The foul flush unit is visible in the lower left corner.**

The rainwater catchments installed on our previous visit were limited by the capacity of their storage tanks. On this visit, the team added an additional 5000L of storage capacity to the dormitory rainwater catchment at Muramba College. Our estimates indicate that this expansion will be able to provide an additional 220,000 L of potable water over the course of a year. This is enough potable water to serve an additional 60 people at 10 L per day.

The expansion was accomplished by joining a new 5000 L tank to the existing 6000 L tank for a total of 11000 L of storage. The new tank was about 6” shorter than the old tank and their bases are both at the same elevation. This disparity in height ensures that there is no tank space wasted. Due to the position of the overflow pipe on the old tank, the maximum water level of the system coincides with the top of the new tank. The new tank was connected to the old tank with two lengths of 3.5” PVC pipe and three flexible PVC pipe fittings. The existing tank was drained and the water was stored in 55 gallon drums. Holes were then drilled at the bottom of the tank walls and pipes were anchored in each of the holes with the flexible PVC fittings, water-proof epoxy and silicone caulk. The two pipes were then joined with a flexible PVC junction and secured with large hose clamps. The flexible junction was used to prevent the pipes from coming loose in the event of differential settling between the tanks. The connection pipe was then enclosed in a masonry housing to protect it from foot traffic and the elements. After installation, both tanks were cleaned to ensure maximum water quality.

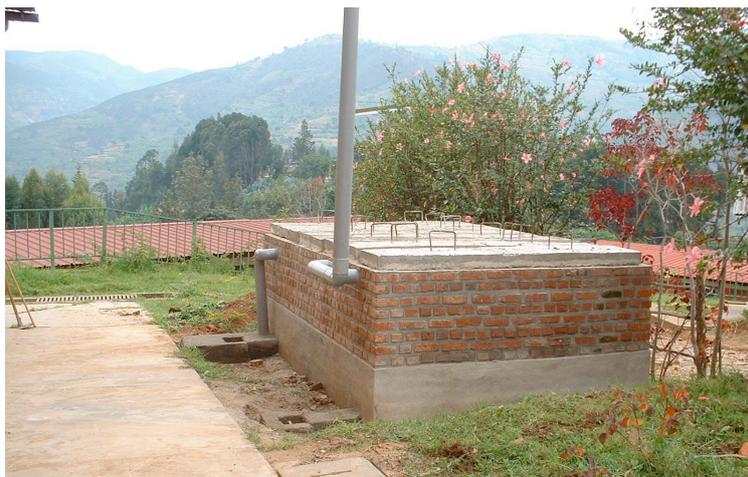
The cafeteria rainwater tank was only two thirds complete when we left Muramba in May, '05. It was two weeks later when we got word that the workers had finished the job. We left explicit instructions on how the tank was to be finished, however some of those instructions were not followed. There were also some minor design flaws that became apparent when we inspected the completed tank. What follows is an explanation of these problems and their solutions.

**The cafeteria rainwater cistern**

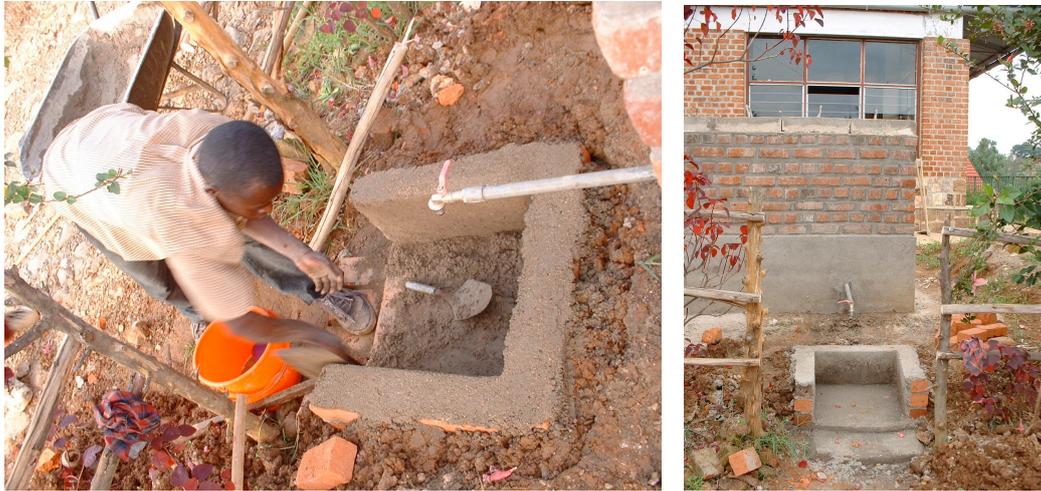
**Left: JP Habanabakize applies a parge coat to the access point masonry. Right: The improved access point**

In addition to the repair of the leaking pipe, the team also performed some improvements on the cafeteria cistern. As initially constructed, the cistern did not have a proper access point for users to draw water from the system. There was simply a tap protruding from the tank wall which provided two feet of clearance for users to place their buckets. We improved access to the tap by constructing a masonry collection point and removing a section of fence to make the tap more accessible. The team also took measures protect the foul flush drain, the main tank drain and the

overflow pipe from foot traffic. Sections of rubber hose were used to connect the drainage taps to a preexisting waste water pipe and the lines were then enclosed in protective masonry housings.

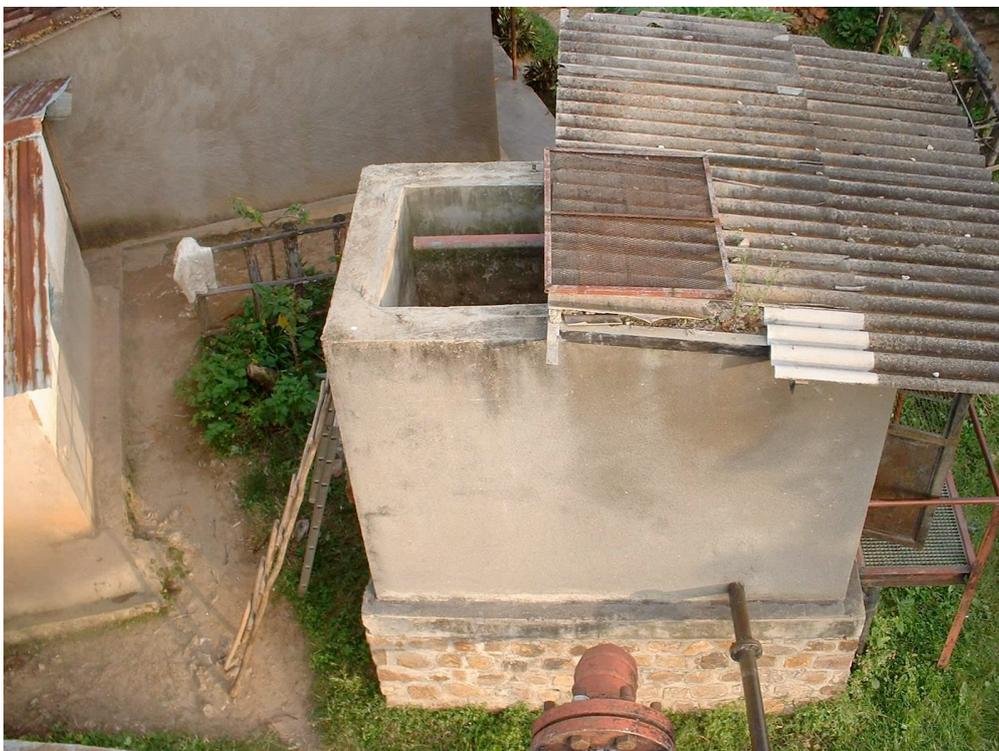
**Photograph of the filter body and valve house taken from the top of the backwash tank**

In order to improve the water quality at Muramba College the team implemented a rapid sand filter to treat water before it enters the College reservoir. This was accomplished by upgrading our previous implementation of a gravel filter in a pre-existing filter body that had fallen into disuse. It is our understanding that the filter body was originally constructed in 1989. According to the locals, the filter had been abandoned less than a year after its installation and had remained so until our gravel filter implementation in May, 2005. The reasons cited were a lack of qualified technicians, the community's lack of understanding of the relationship between clean drinking water and improvement overall community health and technician apathy. Upon our arrival this January, the gravel filter was functioning properly. With the appropriate filter body, plumbing for backwashing and distribution lines already in place, the upgrade of the gravel filter to a sand filter was a fairly straight forward task.

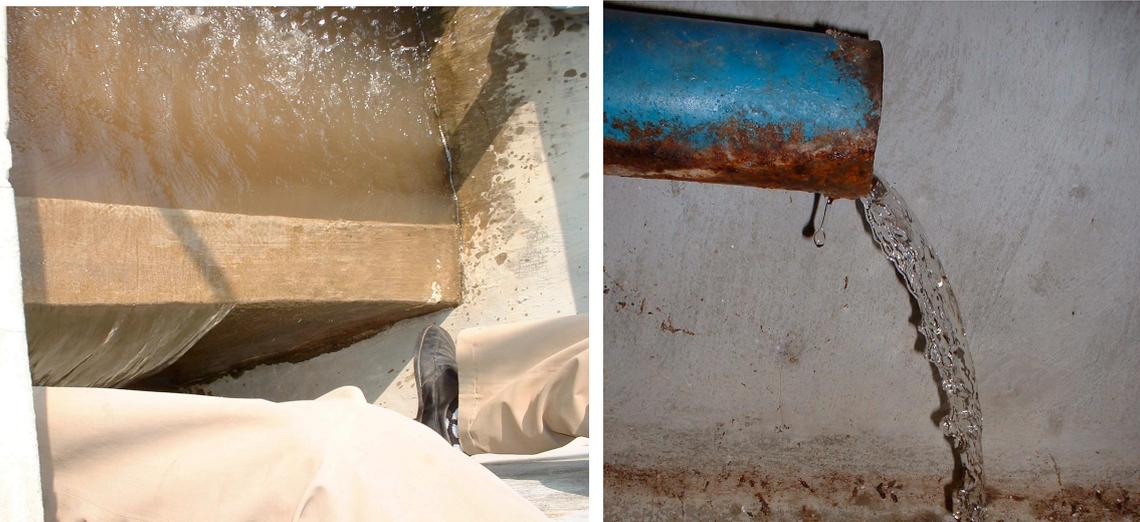
**Left: Water flowing over the spillway during the initial backwash. Right: Filter effluent after the backwash. While the water looks clean, it may still be contaminated.**

The sand was transported in buckets one quarter mile from the nearest road to the filter; this was done with the help of ten student volunteers from Muramba College. The filter was deactivated and 11” inches of sand was placed above the existing 19” of gravel for a total media a depth of 35”. The filter was backwashed to clean and re-grade the media and to remove ultra-fine particles. The filter was then reactivated. The filter now has a maximum freeboard of 24” and was observed to be operating properly. The filter effluent was clear to the eye but we were unable to scientifically test the effluent due to lack of time.

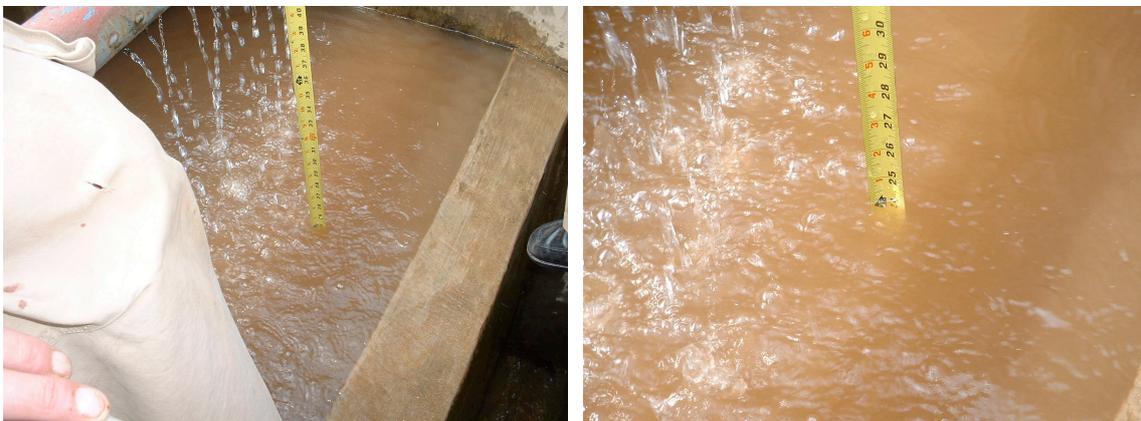
**Measurement of the maximum freeboard during the backwash process. The end of the tape is resting on top of the sand layer; the waterline is at 24".**

In addition, the team should continue to monitor the performance of the filter during subsequent visits. While we believe that the filter will perform as intended, there is a chance that further modifications will need to be performed to ensure optimal performance. Depending on how effectively the filter is handling the large flows associated with the rainy season, we may have to increase the maximum freeboard of the filter. This would provide the higher filtration pressure necessary to handle large volumes of water. The maximum filtration rate is directly related to the maximum freeboard level; any flow to the filter that exceeds this maximum rate will cause the excess water to overtop the spillway and go to waste. As it stands, the filter has a maximum freeboard of 24"; increasing this value by removing some gravel or raising the spillway will enhance the capacity of the filter should the need arise. Increasing the freeboard level would also lengthen the backwash interval as the extra pressure would allow the filter overcome more head loss in the media.

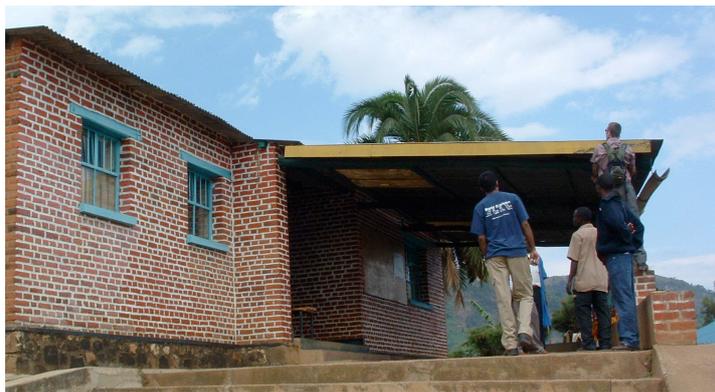
Upon arrival in Muramba, the team decided to install the first lighting system at the clinic. An initial assessment of the maternity building deemed that the clinic roof was not a suitable location for mounting the solar panel, because it is made out of old, extremely fragile fiberglass. Instead, the panel was installed on the clinic’s metal porch awning. The rest of the installation went very smoothly. Heavy duty zip ties, clear silicone, and masonry anchors proved vital to the installation.

**Inspecting the maternity building’s metal awning, where the panel was installed.**

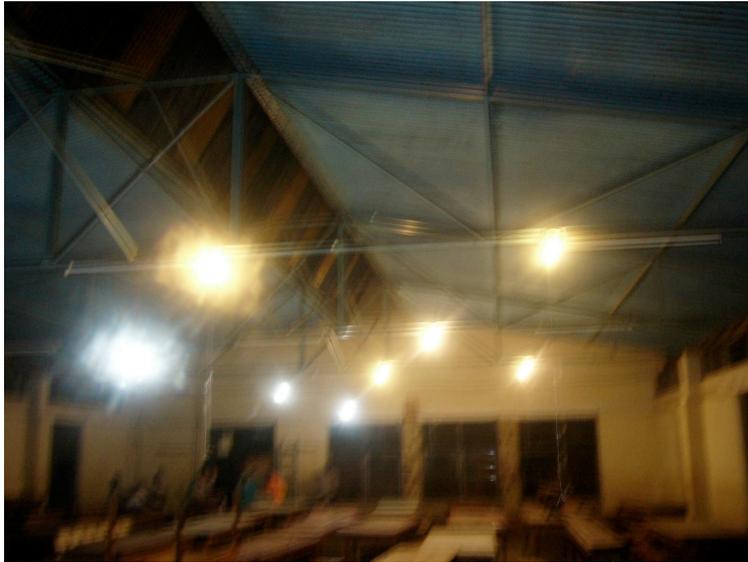
The panel was mounted on the roof of the kitchen, adjacent to the cafeteria. The battery and controller were placed in a storage room directly below the panel. Again, one wire was run from the electrical box and the lights were wired in parallel. Although all the lights did work, sometimes they did not turn on all at once. This was due to the voltage drop in the line from the controller to the lights. The run was roughly 50 ft, causing a large voltage drop for a 12V dc system. We believe that running separate lines to each light during the next visit will fix this problem.

**The finished product. The five lights installed by EWB-CU can be seen here alongside the three existing solar lights (white colored lights, on left), providing total illumination.**

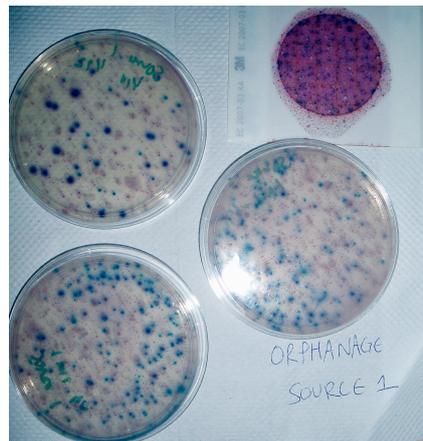
The major concern from these results is the high levels of E. coli contamination found in both the contributing streams and the main source that will soon be pumped directly to the orphanage. The E. coli counts at the Orphanage – Source to be pumped was 12,500 CFU/100ml on the rainy day. This is approaching contamination levels of raw sewage. (Image shows plates – blue dots are E.coli, pink are total coliforms).

**Bacteria testing results for the Orphanage**

There was a significant drop from the rainy day to the dry day, though 2,200/100ml is still a very high level of contamination. There is also an incredibly high amount of total coliforms in all the samples tested in this area. This level of contamination is a major concern, especially as this water will soon be pumped to the orphanage and the children will begin to get their drinking water from this source. The water that they are currently drinking (see below for results) is of a far higher quality, and if this project is completed, it would be expected for stomach related illnesses to skyrocket. The team informed Victor Monroy, the director of the orphanage of these concerns. We hope to continue to work with Victor to help come up with a solution that will benefit the children and keep them healthy.

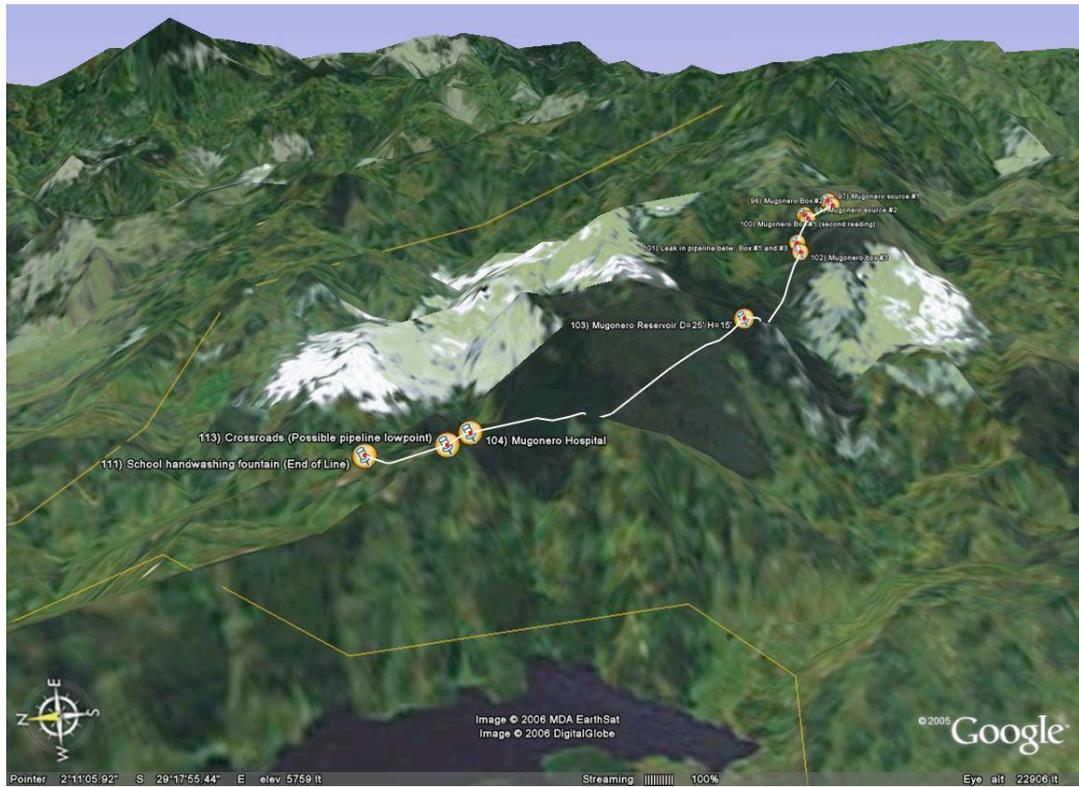
Our research shows that there are three fundamental areas that need improvement in the Mugonero water distribution system: quantity, quality, and security. From a quantity perspective, the system is inadequate because the sources do not provide enough water during the dry season. The quality of the water is compromised by the fact that the watershed that feeds the sources doubles as a pasture. On all three visits to the source area, cattle were observed grazing in the collection area. Cow dung was observed in some of the streams that feed the collection pits. For more information on the water quality of the Mugonero pipeline, see Section 11. There is also some concern about the security of the pipeline; there are reports of people who live along the pipeline intentionally breaking the pipe to access the water. There is also some concern about what someone with more sinister motives could accomplish given the accessibility of the pipeline and reservoir.

**Mugonero Hospital water pipeline (Elevation exaggerated 3x)**

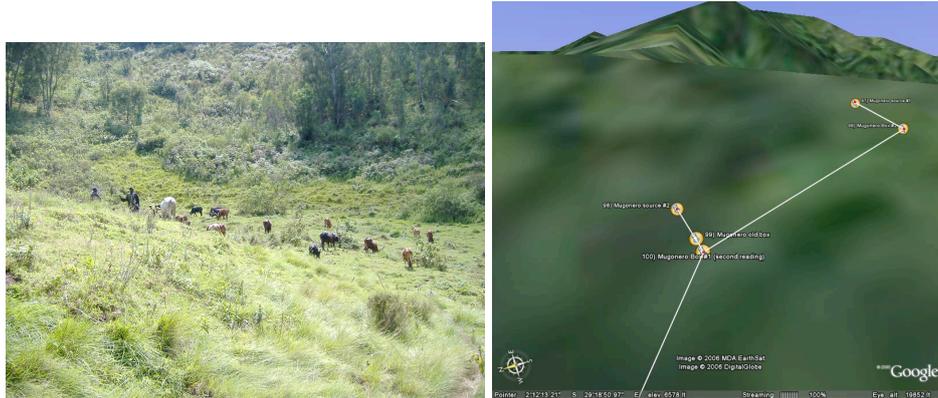
There were two collection pits identified by a hospital technician who accompanied us to the source area, however, we believe that there may be a third pit whose location is unknown. The presence of a third collection pit is evidenced by a flow of unknown origin entering collection box #1.

**Left: A herd of cattle grazing at the source area. Right: Map of source area**

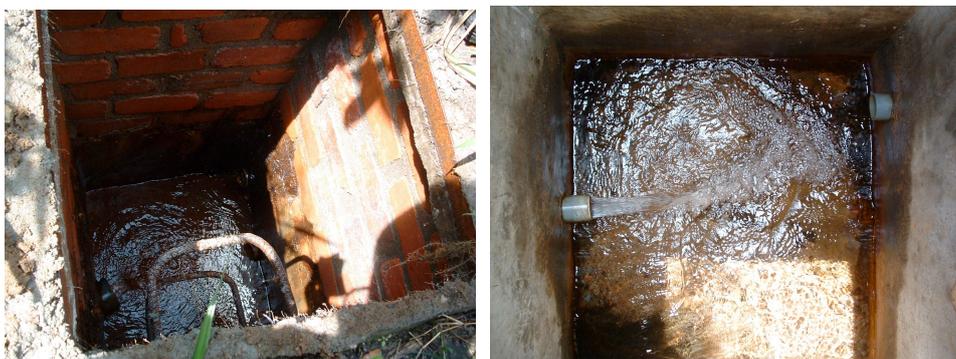
The contributions from all sources merge in box #1 and travel to box #3 along ~500 ft of ~3” pipe. Midway along this pipe is a large hole that is sometimes plugged with a piece of tree bark. It is likely that this hole was created intentionally by local residents. Box #3 receives water only from this pipe and discharges only to the reservoir located another mile down the pipeline. The flow into box #3 was measured to be approximately 45 L/m. This value represents a large fraction of the total water production at the source, with any losses attributable to the aforementioned leak. Water is discharged through a perforated plastic fitting similar to the one on box #1.

**Left: Internal view of box #2. Right: Internal view of box #3**

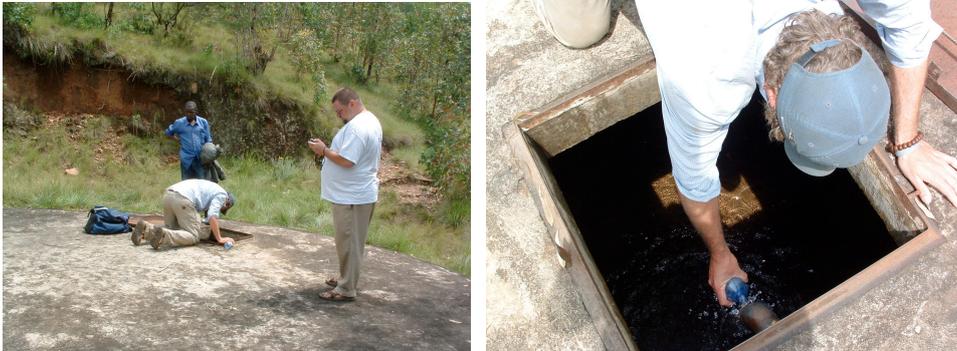
One and a half miles from the source is a large reservoir measuring 25’ in diameter and with a depth of 15’. The total volume of this tank is 7300 cubic feet of 200 cubic meters. The reservoir is constructed of reinforced concrete and looks to be of sound construction. When we inspected it, the reservoir was nearly empty. Locals report that this is normal and that the reservoir is rarely filled to capacity. At the time of our visit, the flow rate into the reservoir was 40 L/m. This is

somewhat less than the flow rate measures at box #3 indicating that there are some losses in the intervening pipeline. It is likely that these losses are due to impromptu “tap” made by the locals.

**An EWB team member collects a water sample at the reservoir inlet.**

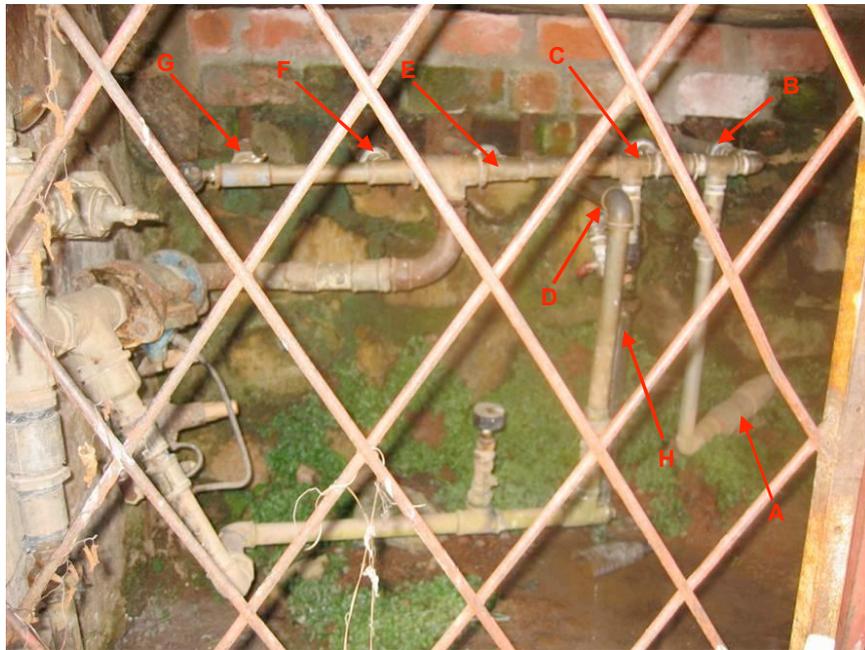
The main pipeline terminates at a valve box located at the south-east corner of the hospital complex. This valve box distributes water to the hospital distribution network via a series of eight smaller pipes which are controlled with gate valves. The distribution network is fairly complex, serving at least 14 buildings and more than 50 individual taps. Many taps were found to be leaking from the closed position or simply left on without regard to water conservation.

**Mugonero valve box (above) and valve labels (below)**

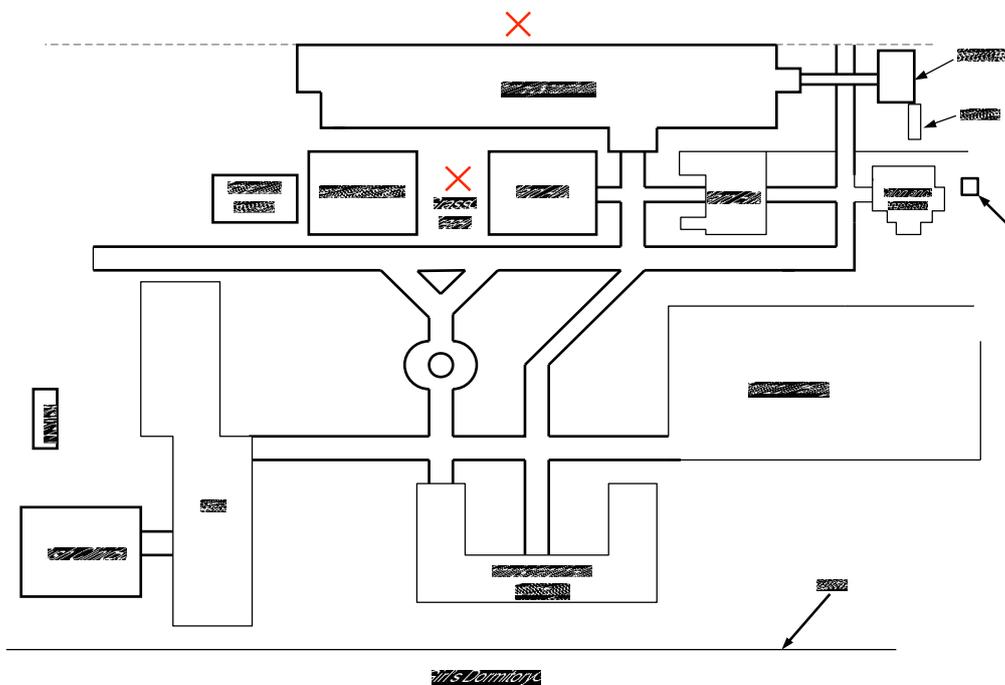
Figure – 12.2.1 Potential RWC sites with a red “X”.

A rainwater catchment system next to the main hospital is attractive because the main hospital building has the largest roof of any building in the Mugonero complex. Figure 12.2.1 identifies the locations of the two sites that were identified for possible rainwater catchment systems. From the figure, one location is behind the hospital and the other is in a grass area between Ward A and the Washroom.

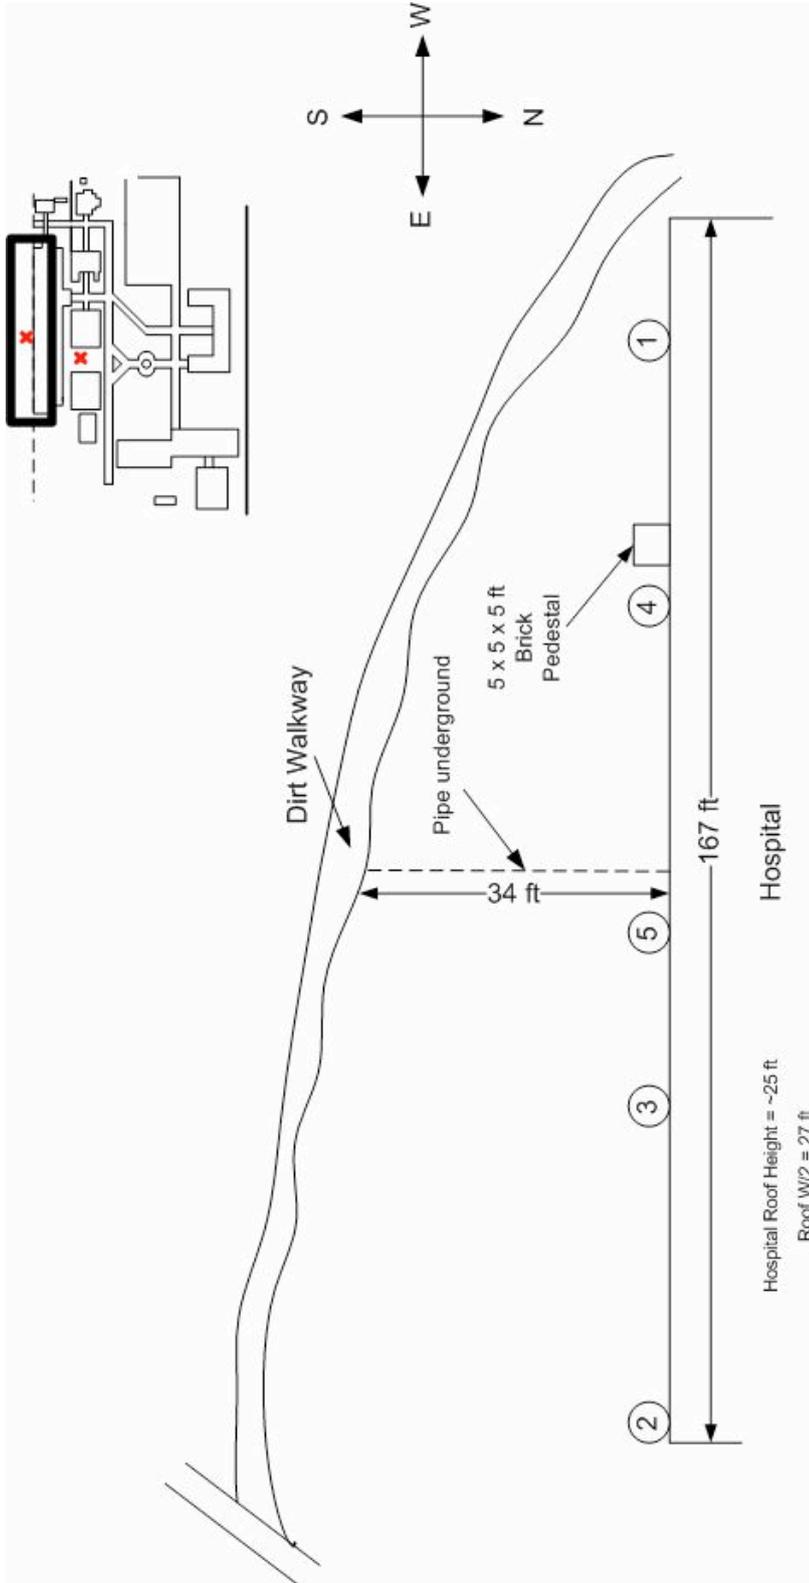
Figure 12.2.2 – Layout of the back of the main hospital building.

It was determined that a central location behind the hospital would be best because gutters can be placed along the backside of the roof. A collection point can be placed in the middle and the water can collect in the centrally located tank. System designers should note that there is a pipe running on the ground from the middle of the hospital. Design steps should be taken to avoid damaging the pipe. A pedestal is located at the back of the hospital in the western corner. Our assessment concluded that this structure would be too weak to support a full storage tank. Future teams can further assess the structural integrity of the pedestal.

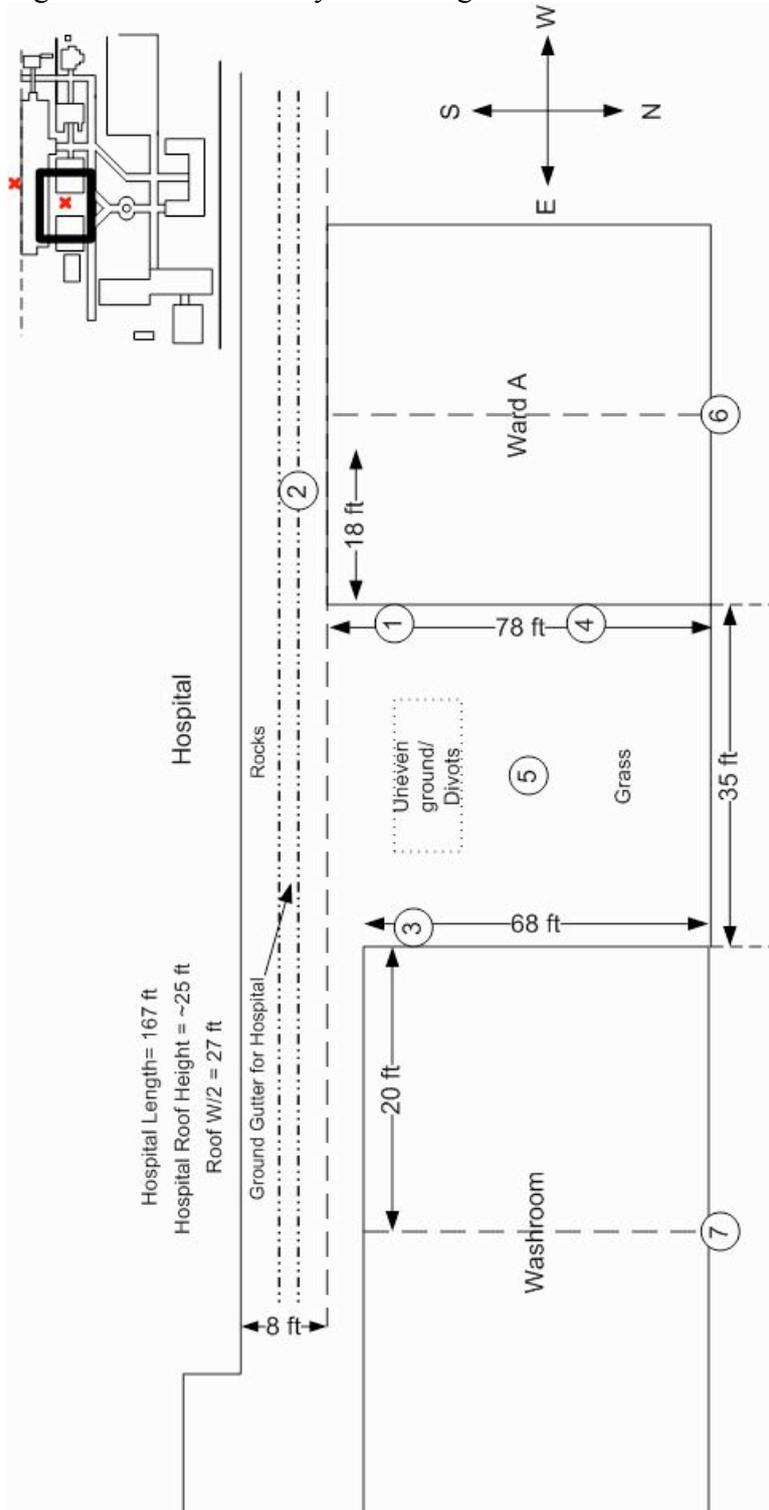
Figure 12.2.8 – Illustrates the area between Ward A and the Washroom. Numbers correspond to picture numbers found in the section.

In the area between the Washroom and Ward A, a storage tank can be placed between both buildings in the grass area. To the south of the grass area is the main hospital. Between the grass area and the main hospital is a ground gutter which catches water from the hospital roof. Future teams can choose to utilize either the hospital, Washroom, or Ward A roofs. Some parts of the grass area uneven and have several divots. Design steps should be taken to neutralize the negative impacts the divots may have.

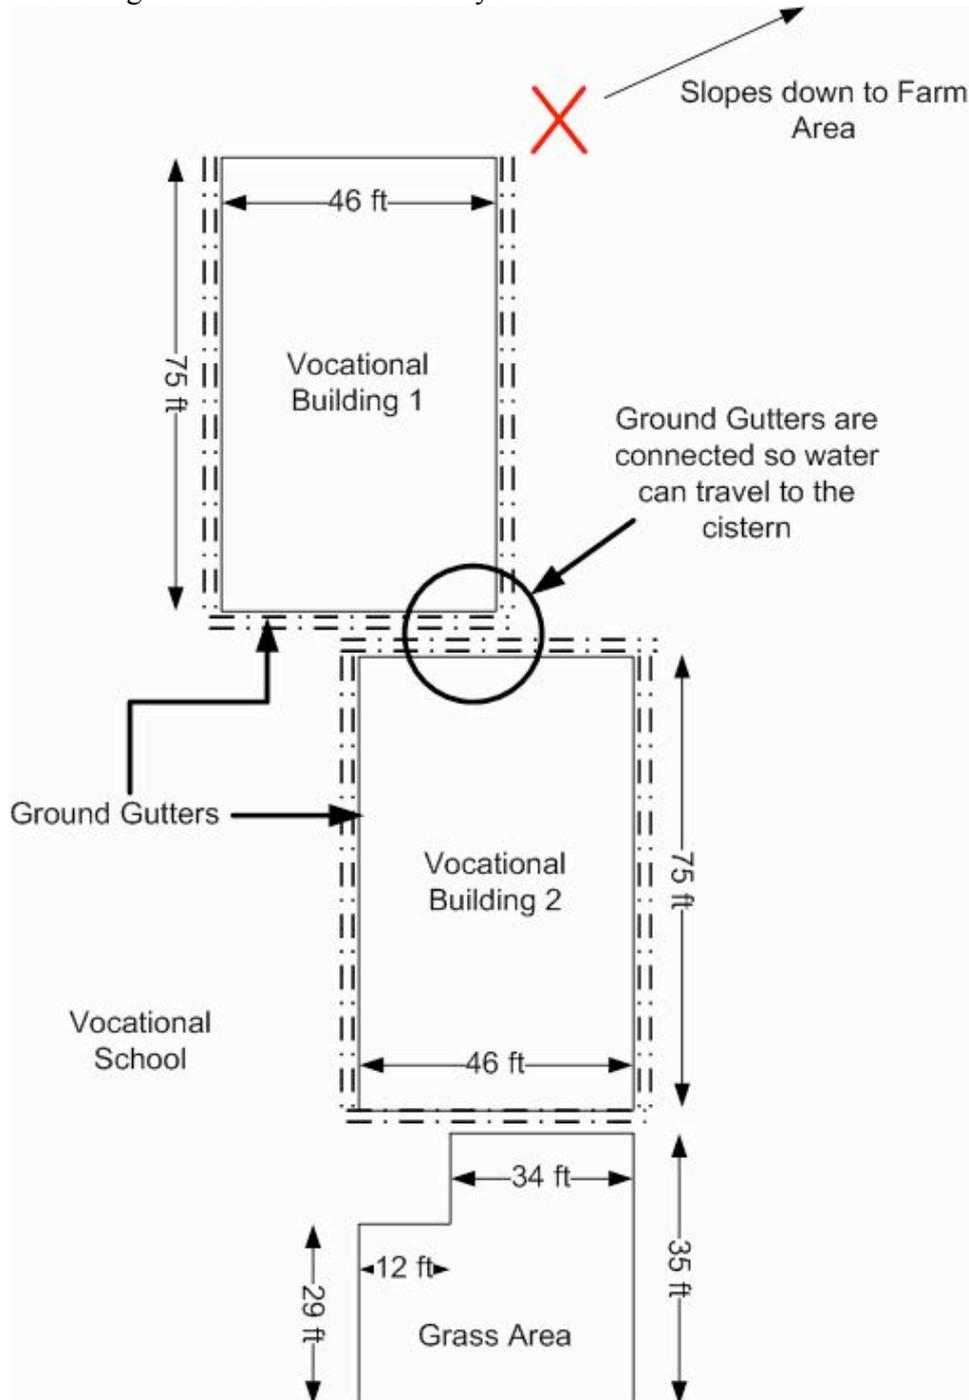
**Figure 12.3.6 – Layout of vocational buildings and rainwater catchment system for irrigation**

As Figure 12.3.2 shows, ground gutters are placed on next to both buildings to capture water from the roofs. The ground gutters from both buildings connect and funnel the water to the collection point marked by the red “X”. Mr. Monroy plans to have a 10,000-20,000L in-ground cistern built at the collection point to provide water for irrigation. As mentioned before, he is currently awaiting confirmation from his funding sources as to whether the project will be completed. The irrigation tank could be a site where Engineers Without Borders can provide assistance in either planning the tank or implementing irrigation. Figure 12.3.7 shows the ground gutter as well as the location for the collection point.

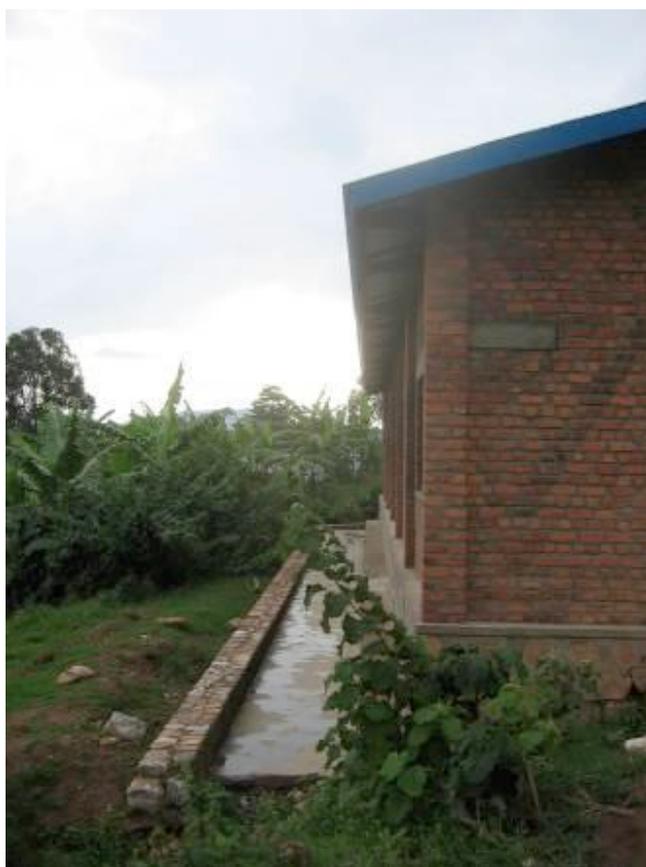
**Figure 12.3.7 - The photograph below shows the ground gutter as well as the location for the collection point**

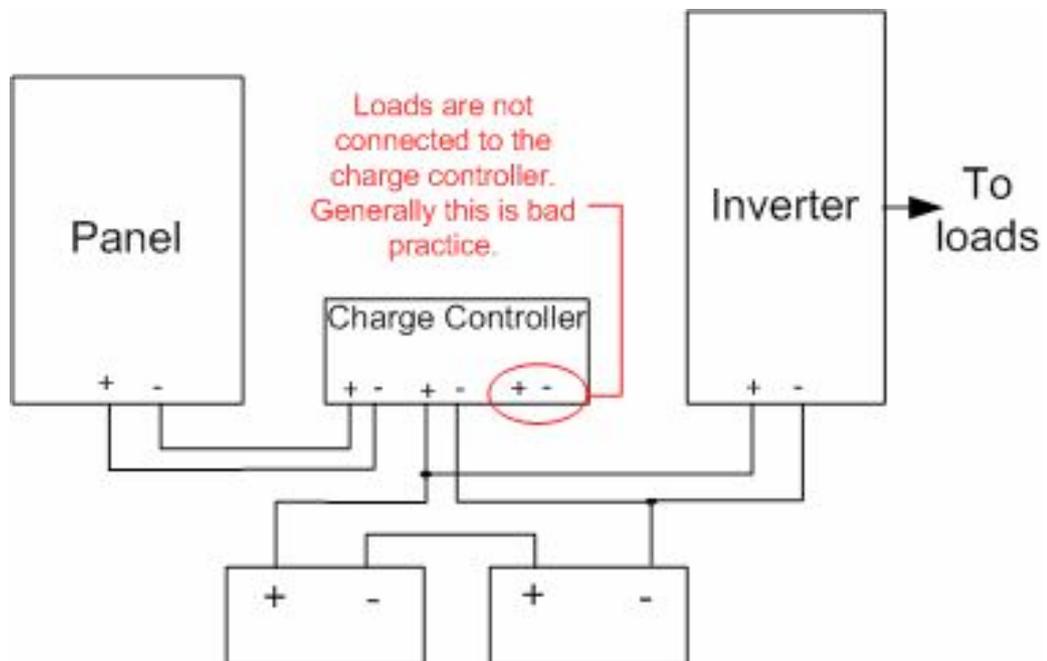
Figure 12.3.9 – Shows the current configuration for the solar lighting system at the orphanage

Currently 6 solar panels are installed on the roof of Mr. Monroy’s office. The panels are connected to a charge controller which charges the batteries. The battery bank consists of two 12 volt batteries wired in series yielding a final voltage of 24 volts. The output of the batteries is sent to an inverter which is then connected to the loads. (Generally, the inverter should also be connected to the charge controller, as this is good practice.) The loads are several lights in the homes of the orphanage. All power may not be utilized in the current configuration and future work can be done to maximize efficiency. Figure
